# Alamo Home Inspections

## Property Inspection Report

Inspection prepared for: [REDACTED]  
Date of Inspection: 6/1/2015

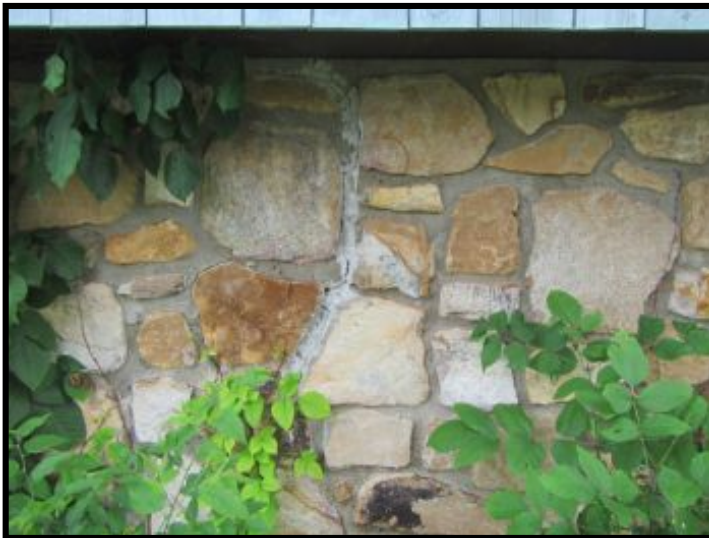
Some hairline separation between the stone siding and mortar in random areas observed.

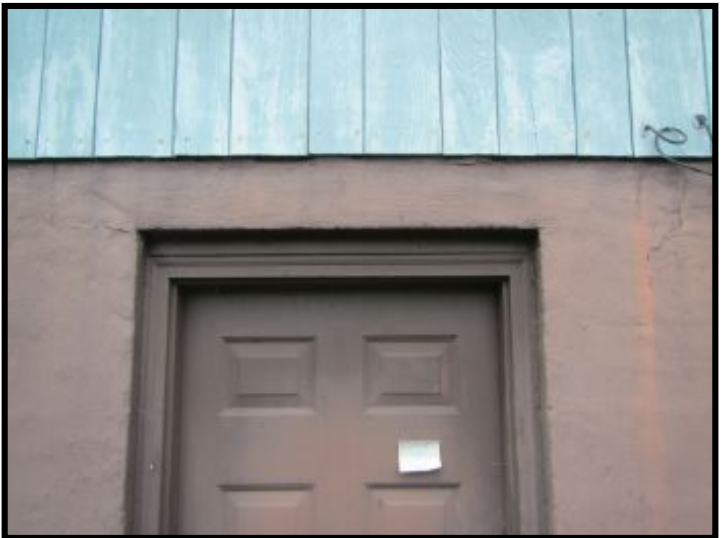
Cracks in cinderblock walls in random areas observed.

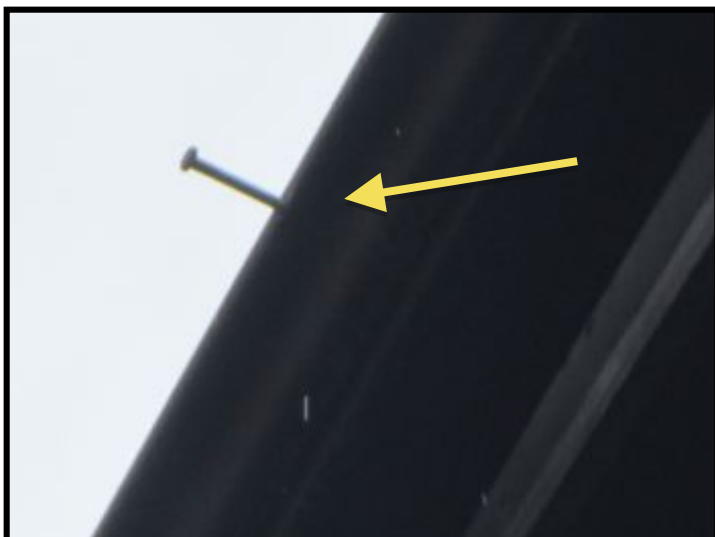
Gutter trough supporting fasteners were backing out at several locations, The gutter trough(s) were insecure at one or more locations. The gutter troughs were pulled away from the fascia at more than one location.

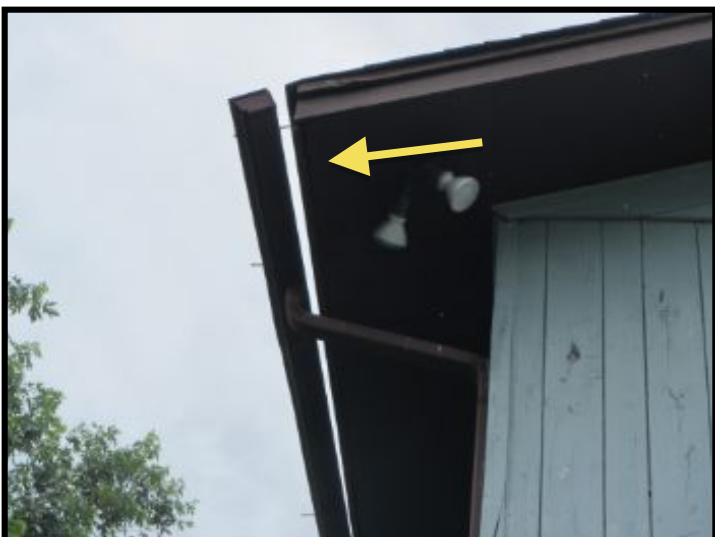
Gutter trough supporting fasteners were backing out at several locations, The gutter trough(s) were insecure at one or more locations. The gutter troughs were pulled away from the fascia at more than one location.

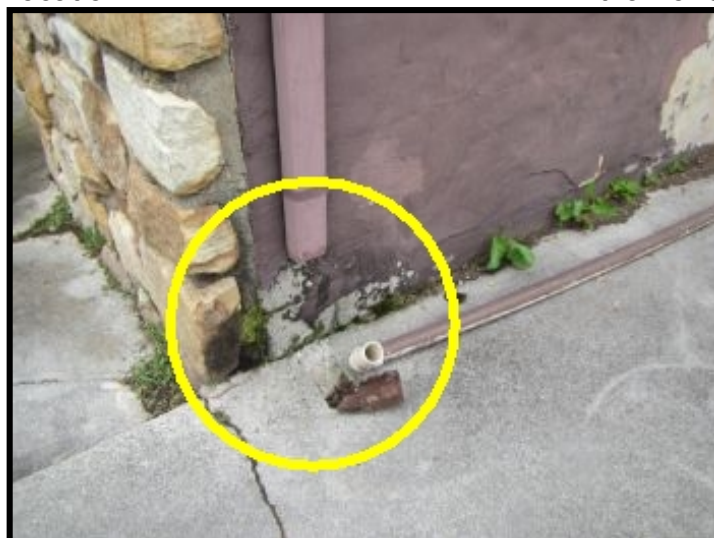
There was no kickout at the bottom of the back right downspout.

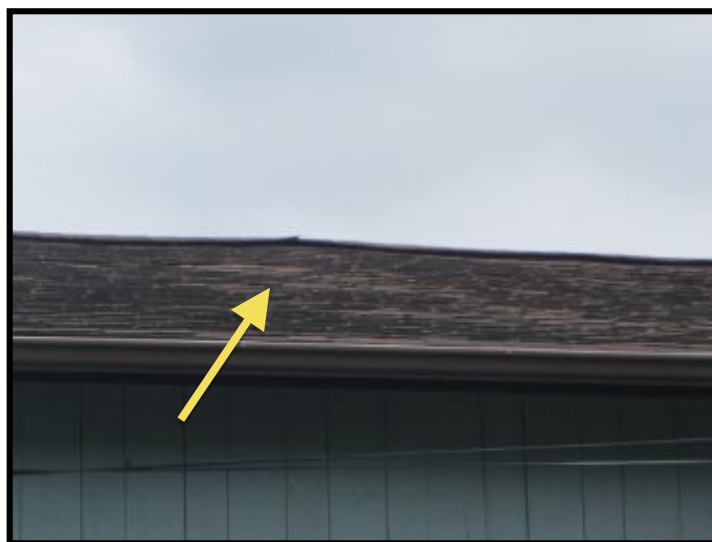
Inspector was unable to access the roof covering. Inspector saw that there appeared to be patchwork to the shingles at more than one location and saw where it appeared shingles were lifted or bulged at more than one location. Inspector recommends having a second evaluation on the condition of the roof covering.

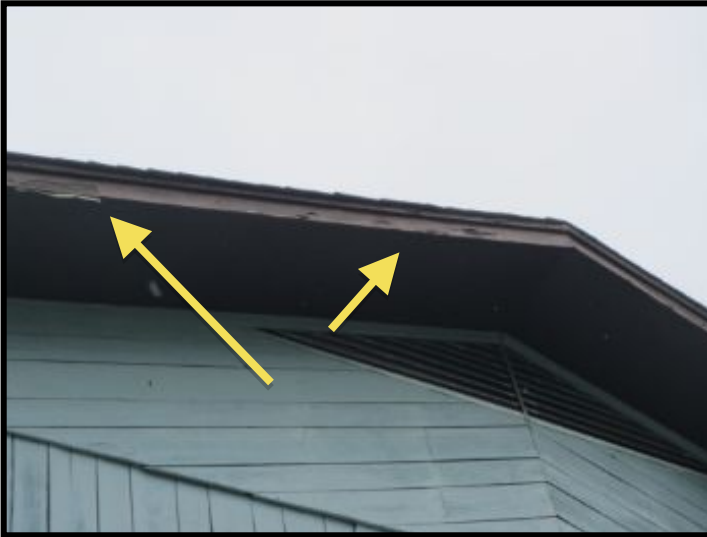
The rake boards had damage at the right side above the garage access wall.

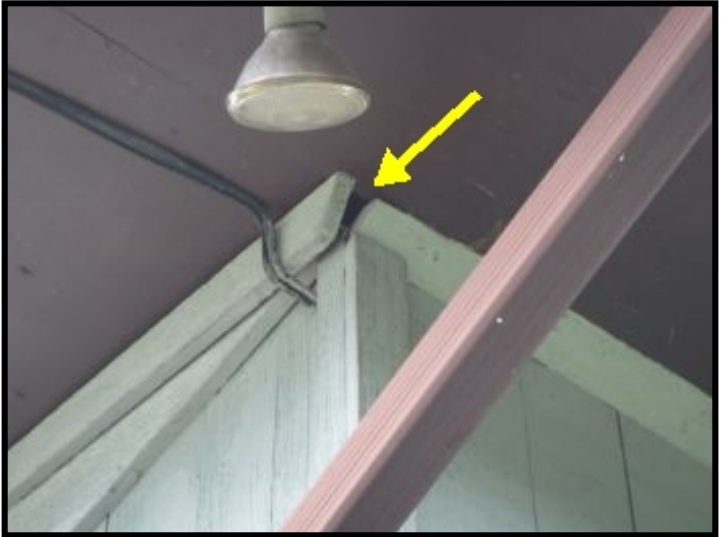
Frieze board was separated and appeared insecure at the back left corner under the eave.

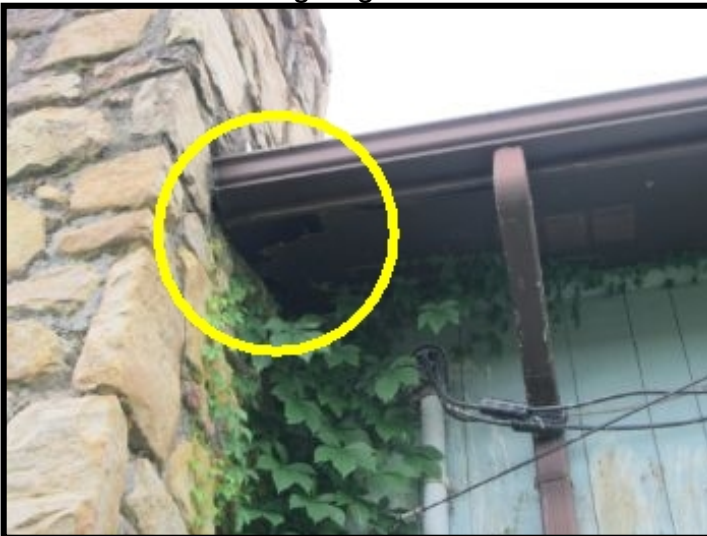
Soffit was rotted through at the side of the chimney penetration.

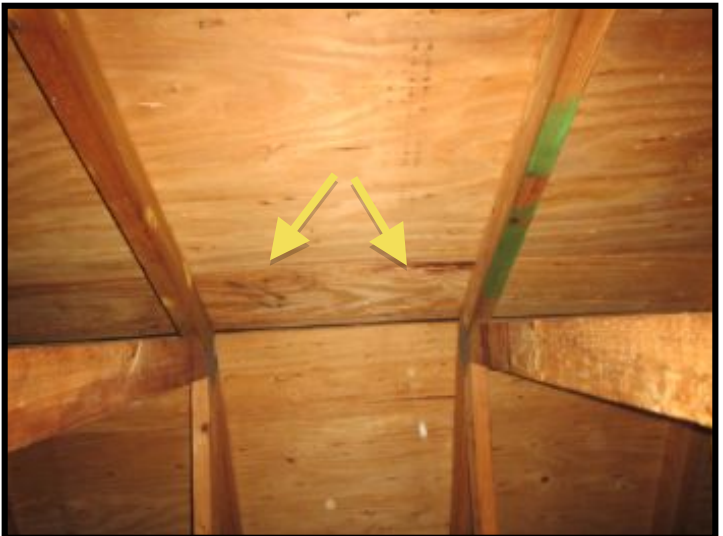
Water stains on decking in random areas in attic. water stains appear to be dry and could be from an old water leak from an older roof covering. Inspectors are unable to determine if stains are new or old. Inspector suggest keeping any water stains found anywhere through the structure a consideration and to monitor the stains during rains.

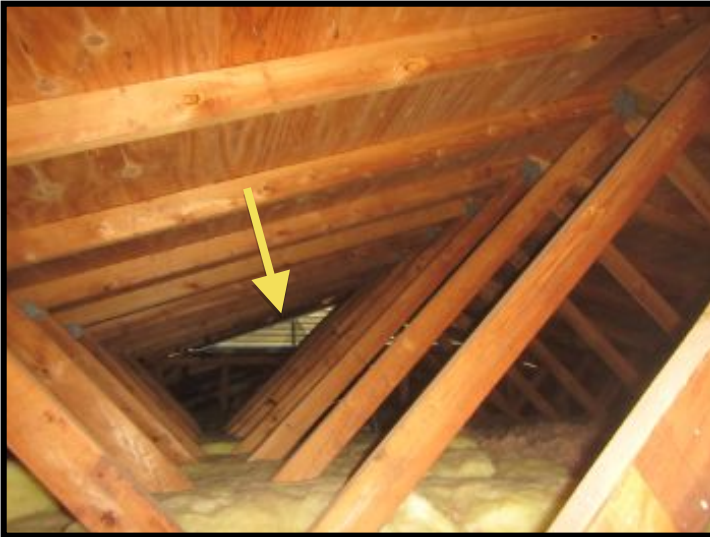
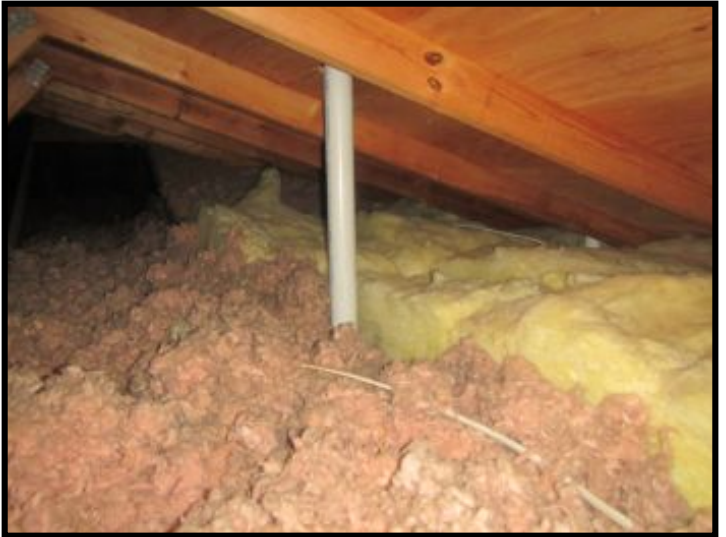
Screen was damaged at the gable vents.

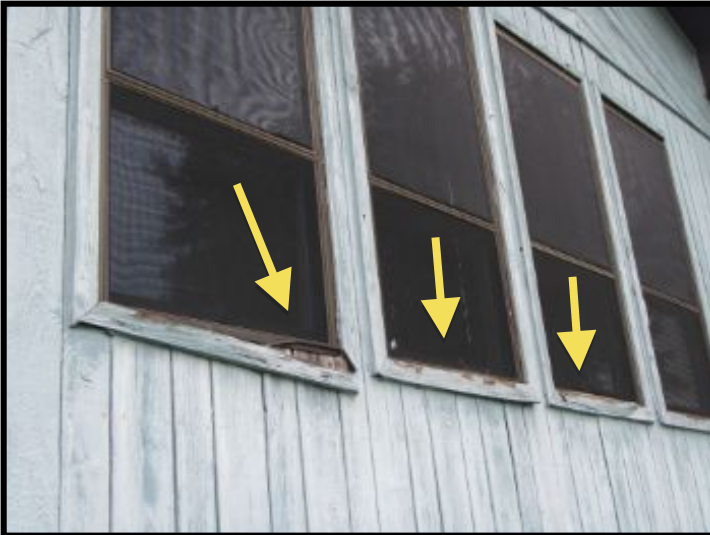
There was wood rot on exterior wood siding at more than one location, including trim around windows and doors.

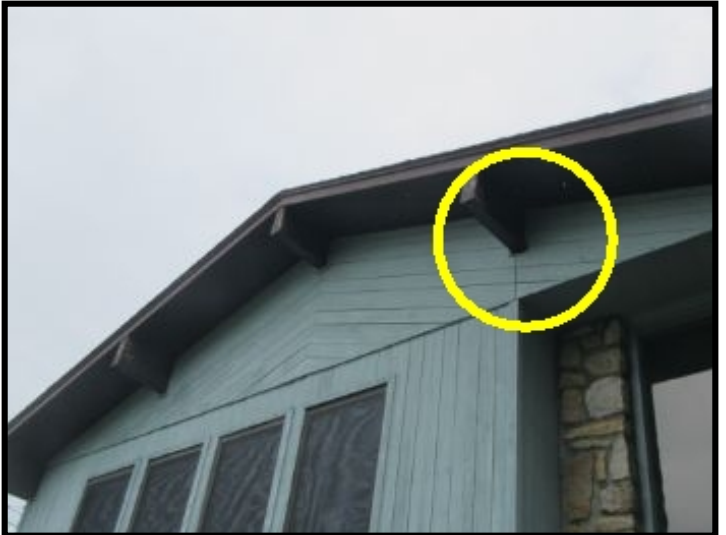
Trim was insecure at the right side beam protruding out from the exterior wall at the front of the living room.

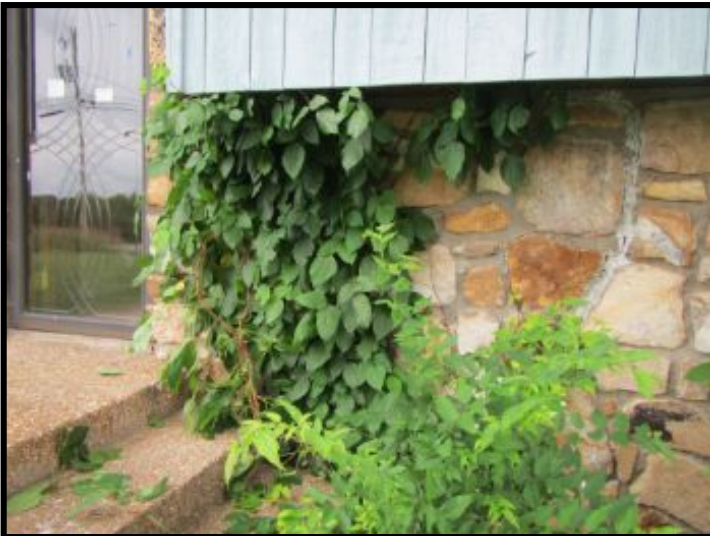
vines restricted inspectors ability to view siding

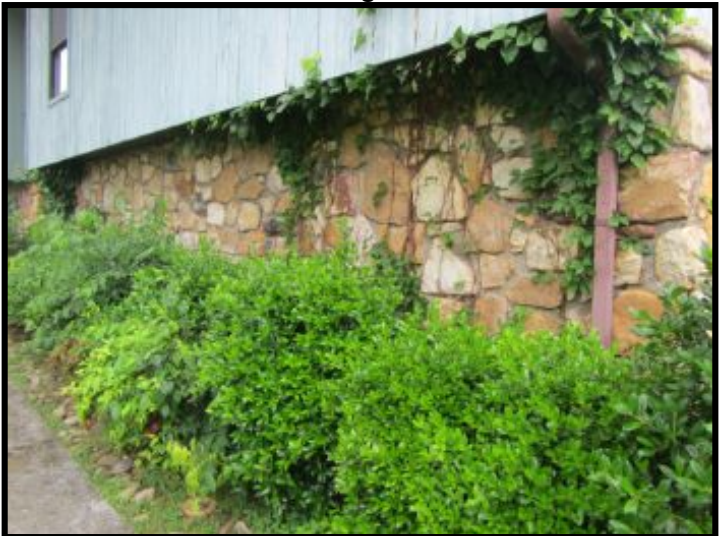
vines restricted inspectors ability to view siding

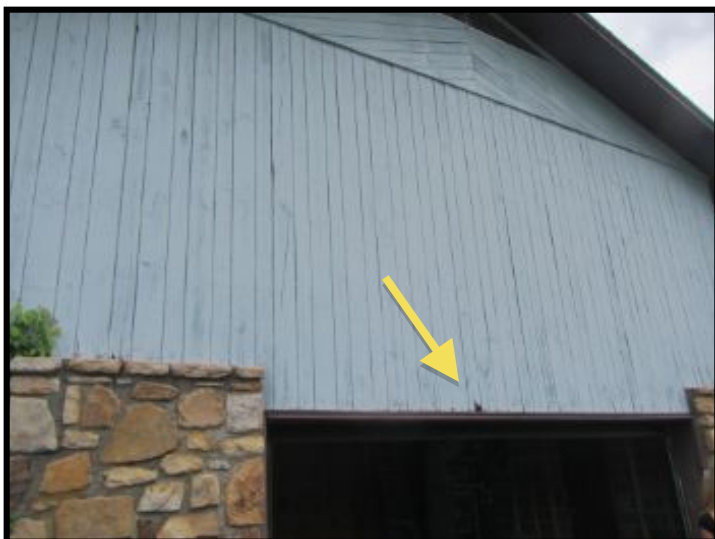
There was wood rot on exterior wood siding at more than one location, including trim around windows and doors.

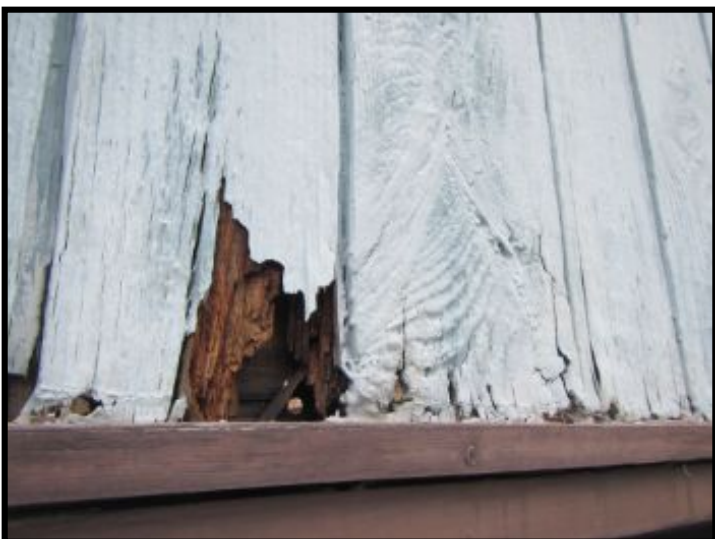
There was wood rot on exterior wood siding at more than one location, including trim around windows and doors.

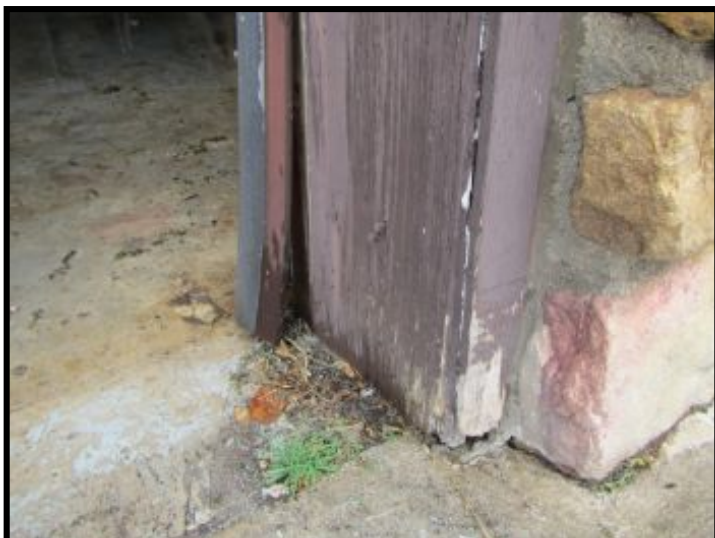
There was wood rot on exterior wood siding at more than one location, including trim around windows and doors.

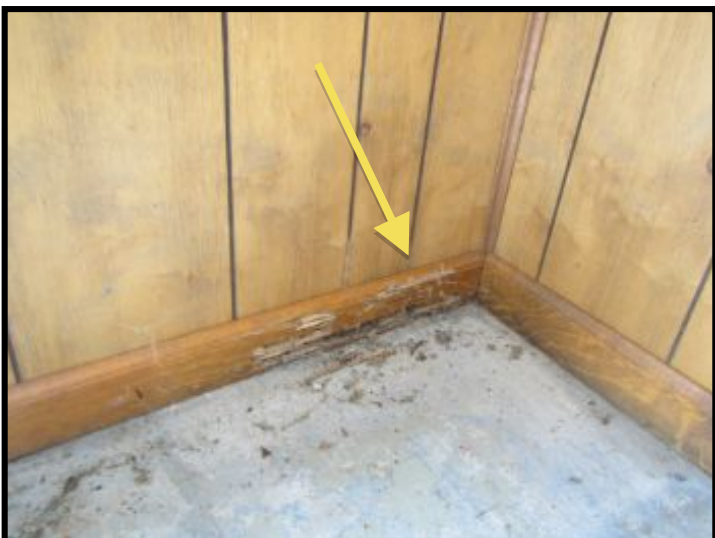
There was wood decay on the baseboards at the front right corner in the garage.

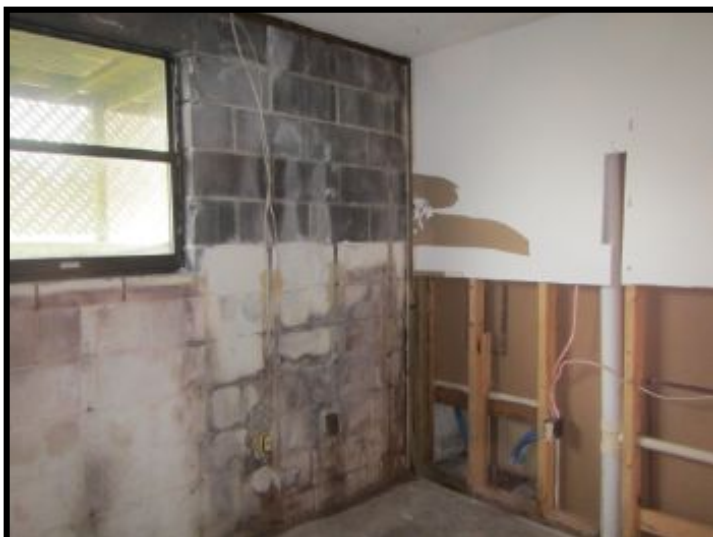
Water stains and Efflorescence on cinder block walls inside the basement. Efflorescence is dried mineral deposits that are transferred from soil/earth by ground moisture through cinder block walls (cinder block being a porous material) on the opposing side of the cinder block wall.

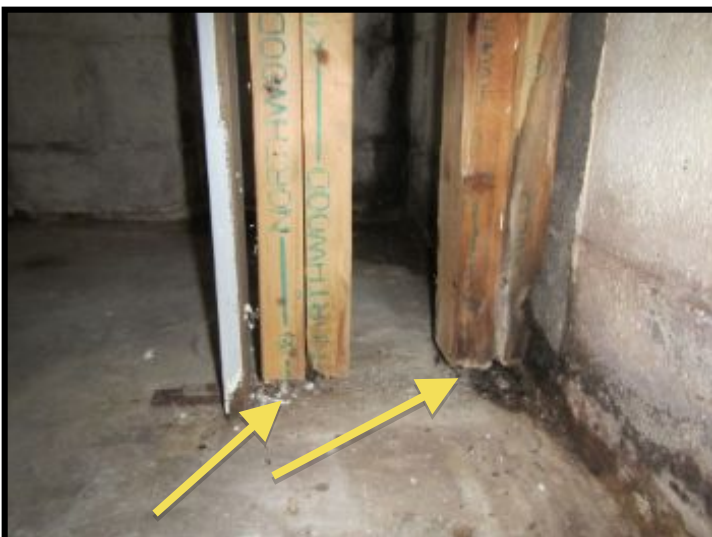
Sill boards were missing at walls in the basement.

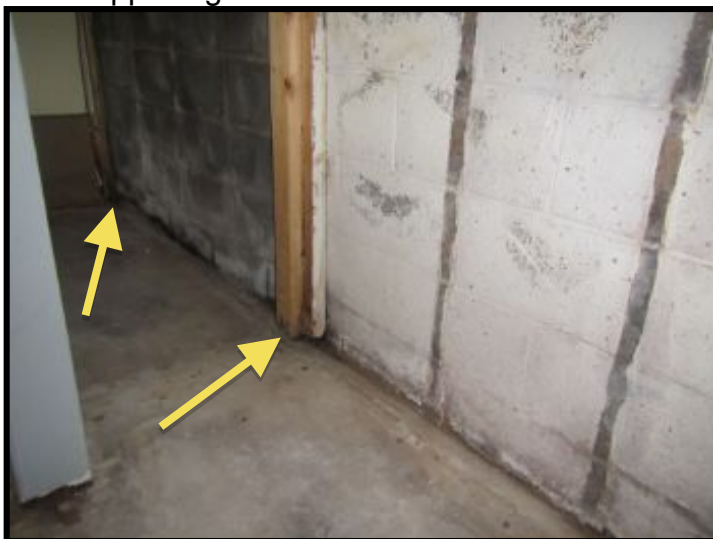
Sill boards were missing at walls in the basement.

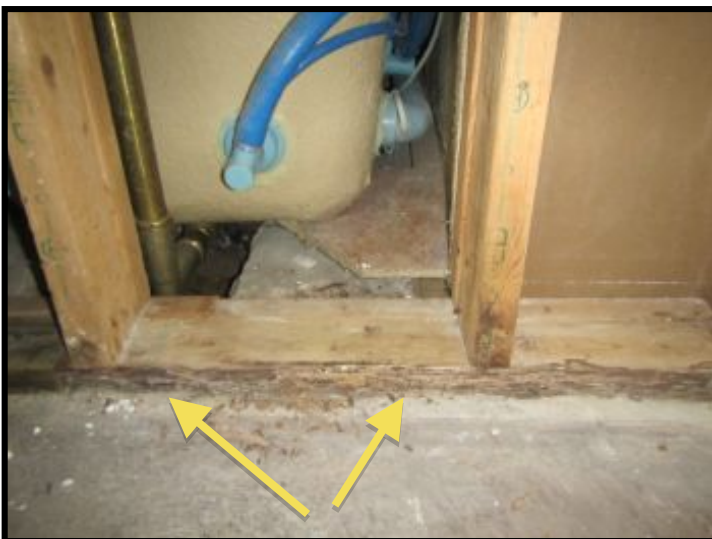
wood rot on sill board behind basement bathtub

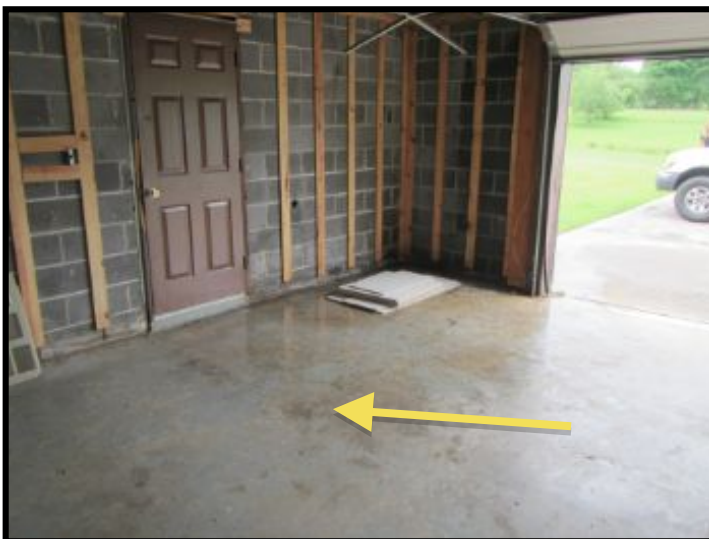
water on the floor in the garage at the time of the inspection

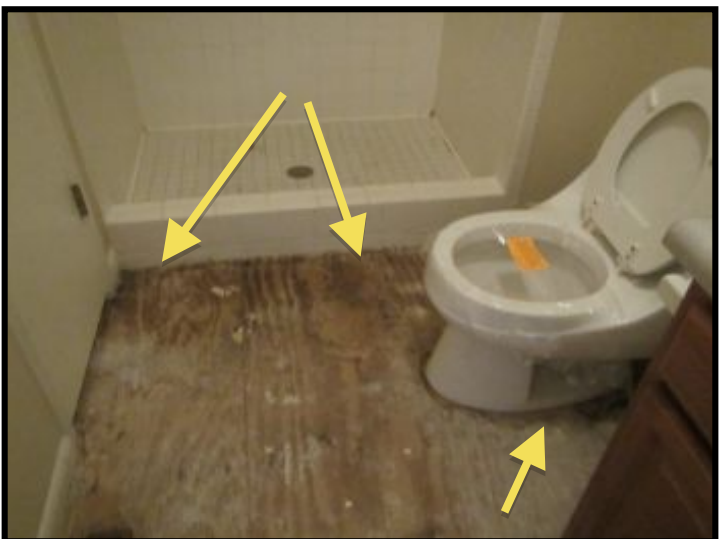
Note that there were dry water stains on the floor of the master bathroom.

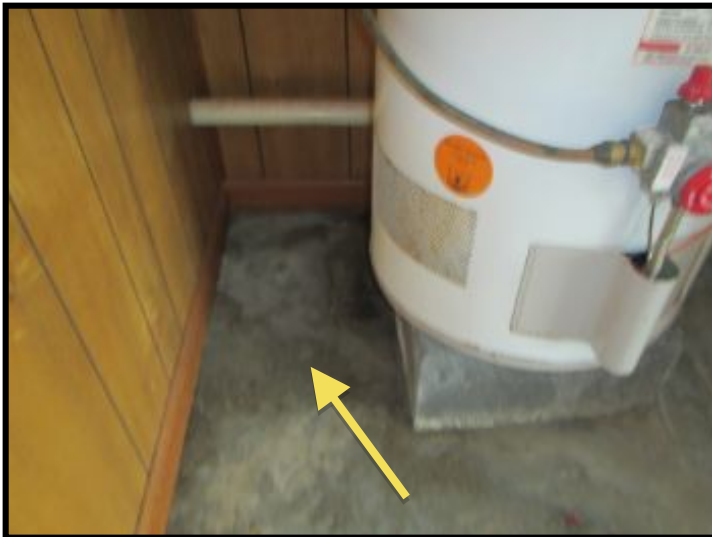
Note that there were dry water stains on the floor below the water heating unit in the garage.

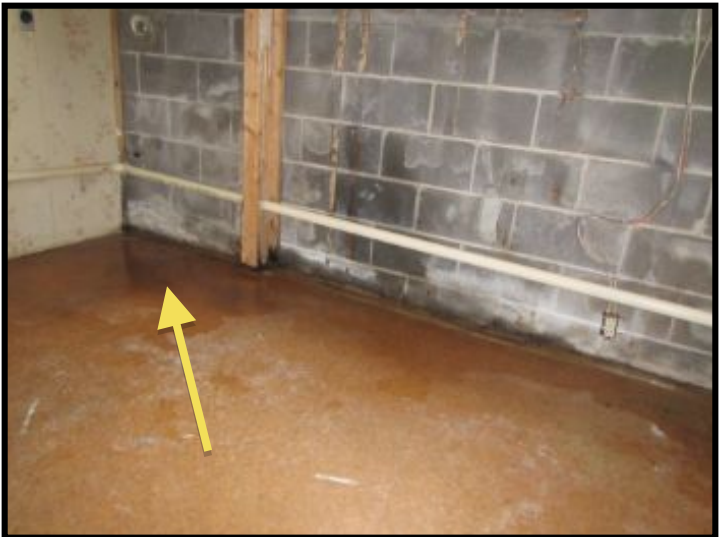
There was water on the floor in the basement utility room at the time of the inspection.

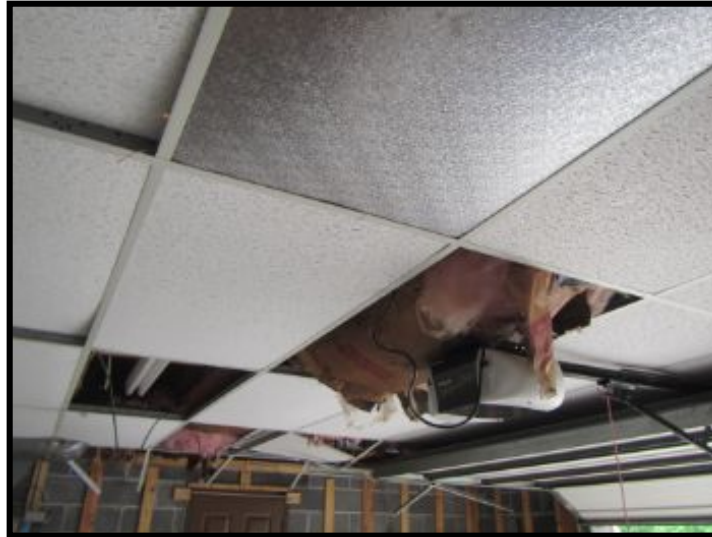
The ceiling was damaged in the garage at several locations.

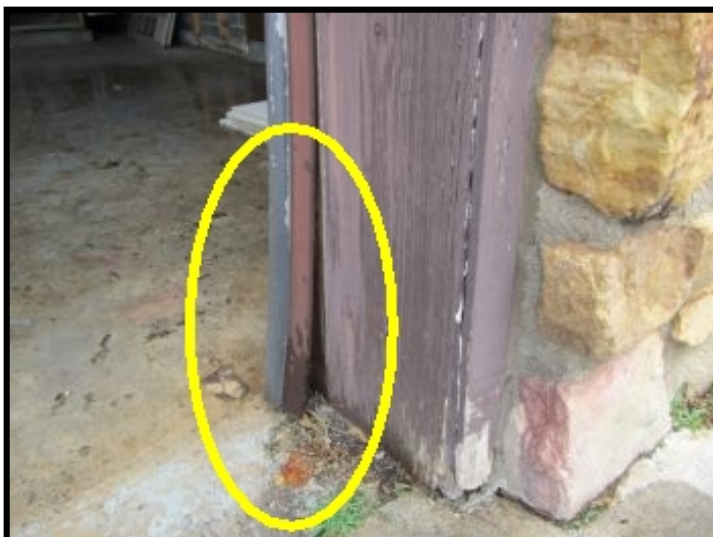
weather strips were insecure at the garage overhead door

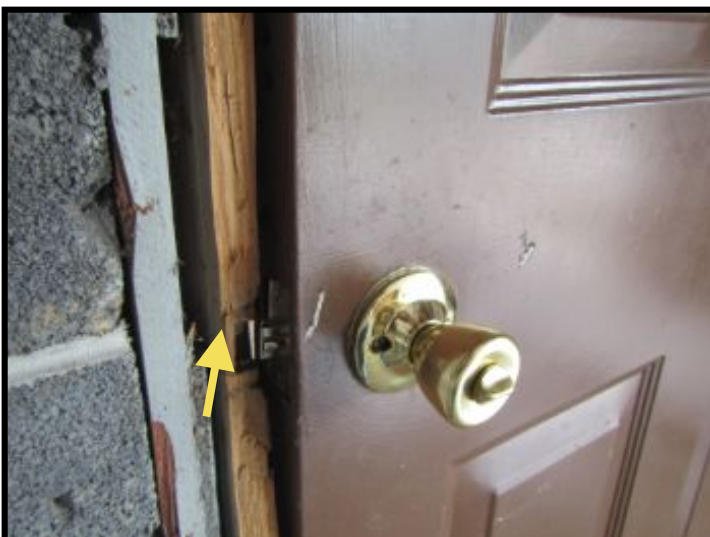
There was minor wood rot on the exterior frame/trim boards at ground level at the back exterior walk through door from the garage. The door did not close and latch in the frame/strike plate.

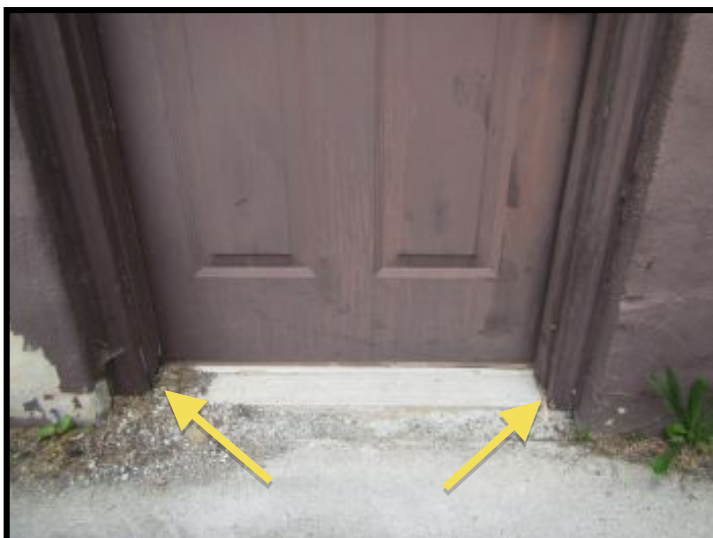
There was minor wood rot on the exterior frame/trim boards at ground level at the back exterior walk through door from the garage. The door did not close and latch in the frame/strike plate.

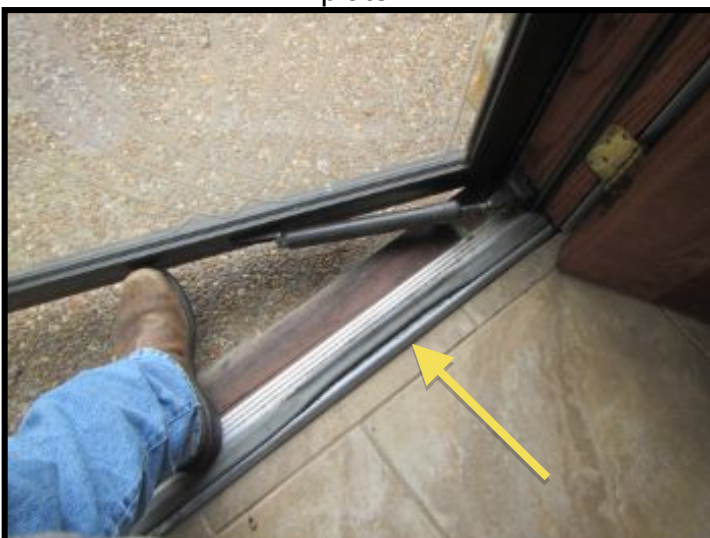
The seal was damaged at the front door threshold.

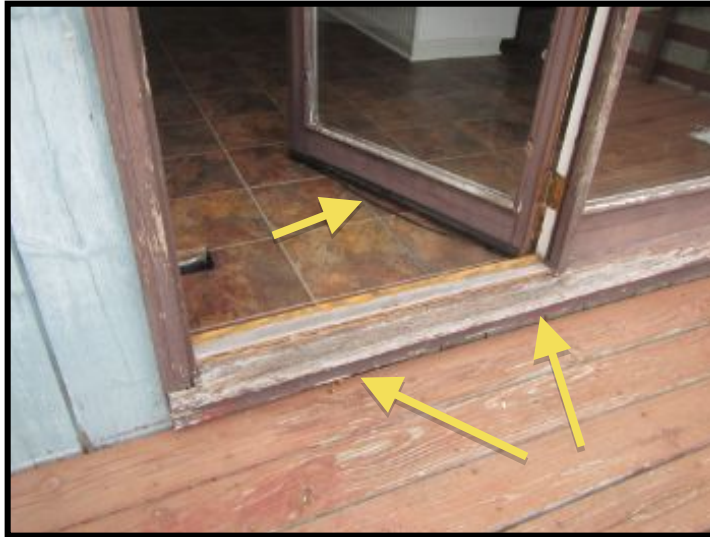
The threshold board was cracked and weathered at the back french door. The weather strip and threshold seal was damaged.

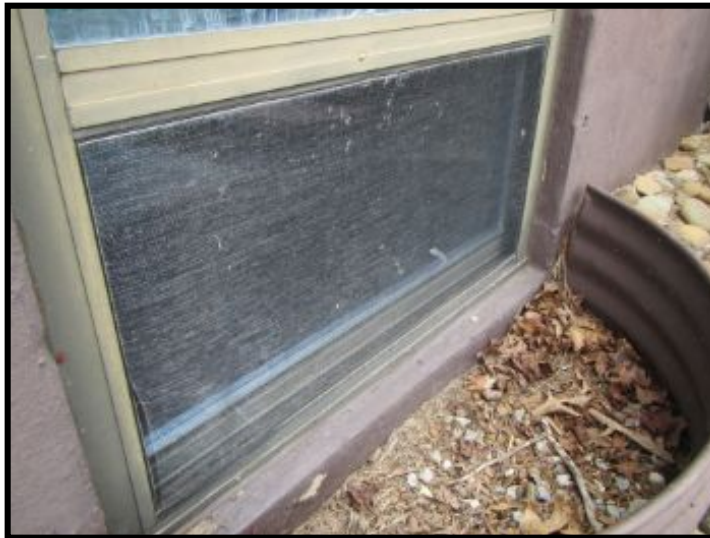
There was screen damage at the basement window at the back of the structure where the well was located.

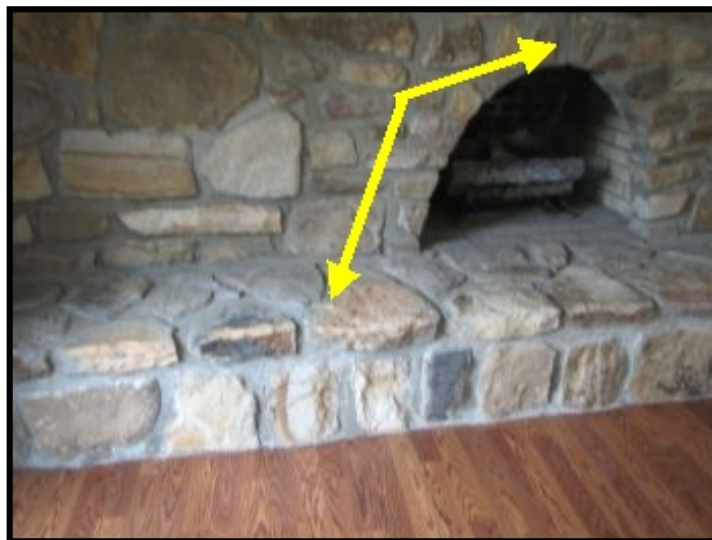
There was cracks in the hearth extension and mantle.

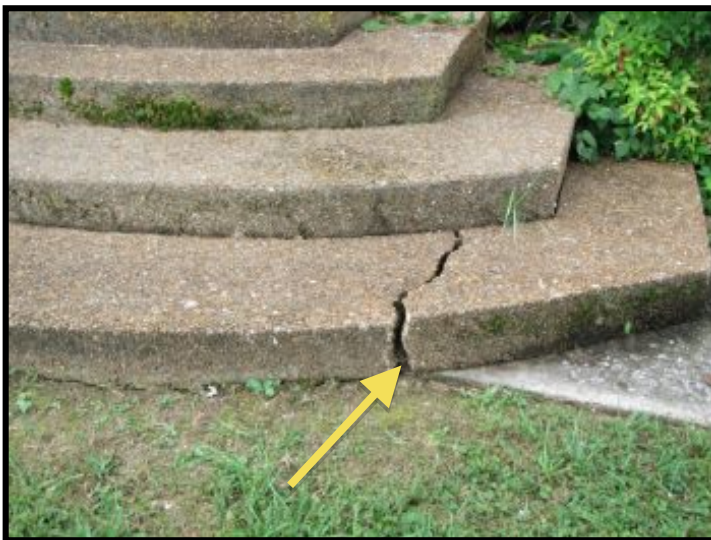
The front porch steps were cracked.

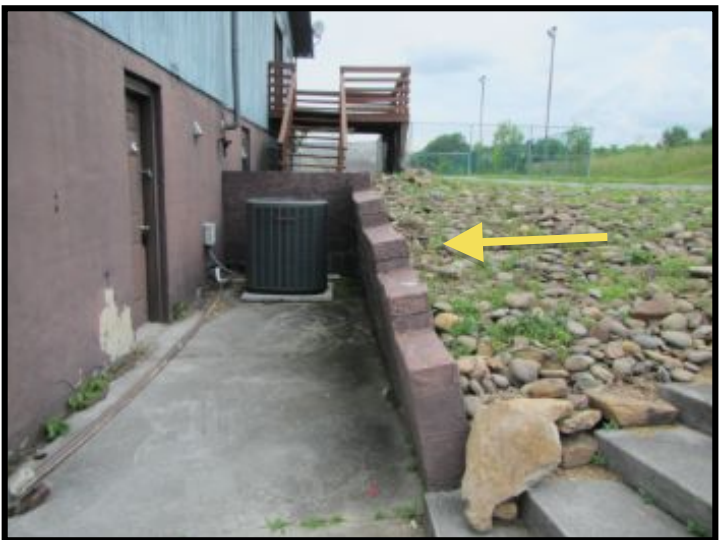
The retaining wall was leaning at the back of the structure.

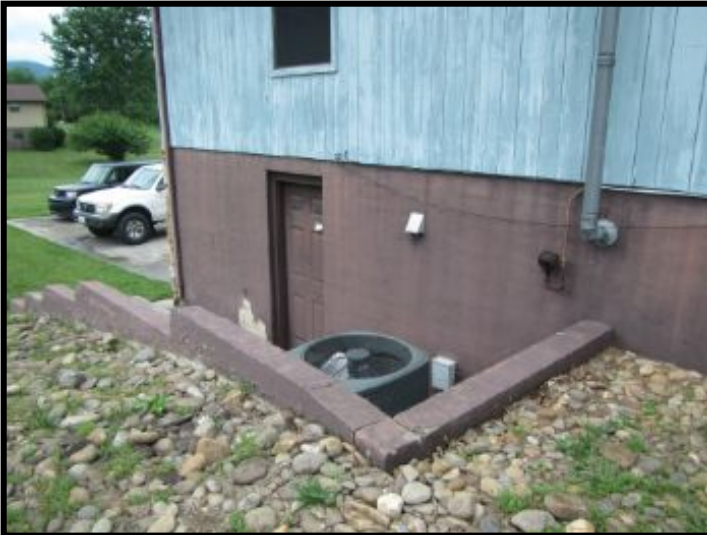
A guard rail should be installed at the top of the retaining wall when the grade differentials are greater than 30" apart per today's International Residential Code building practices.

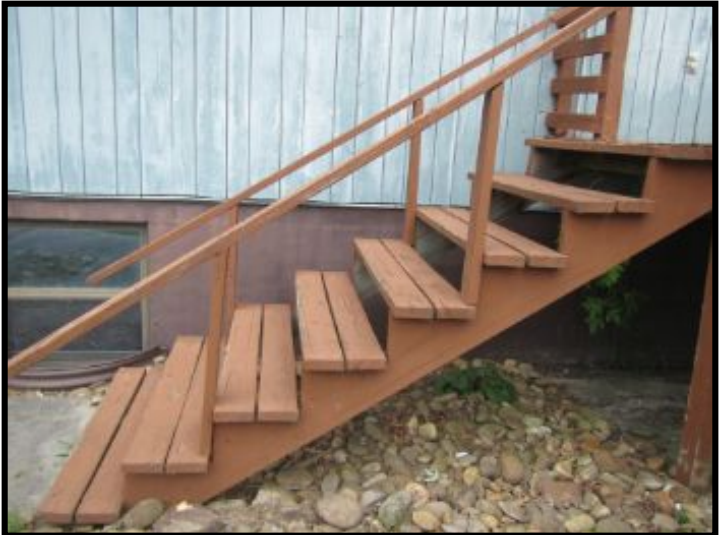
The handrail to the step case was below today's industry standard height and balusters were missing from the handrail.

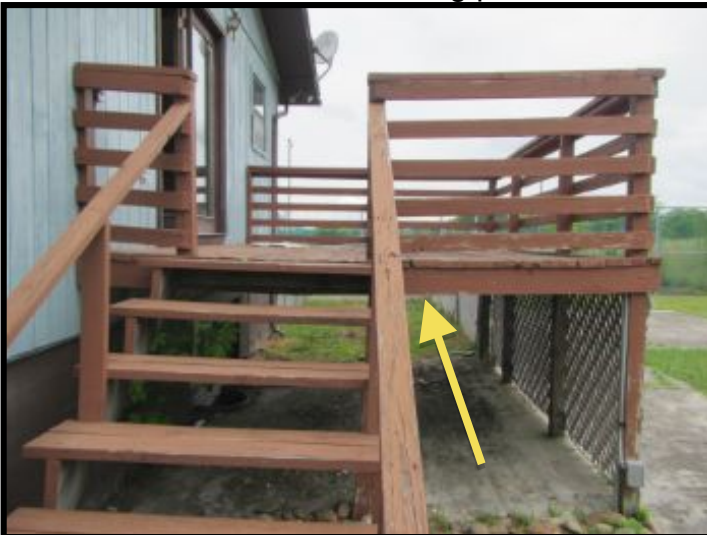
The back deck's joist sagged in the middle/walking surface sagged.

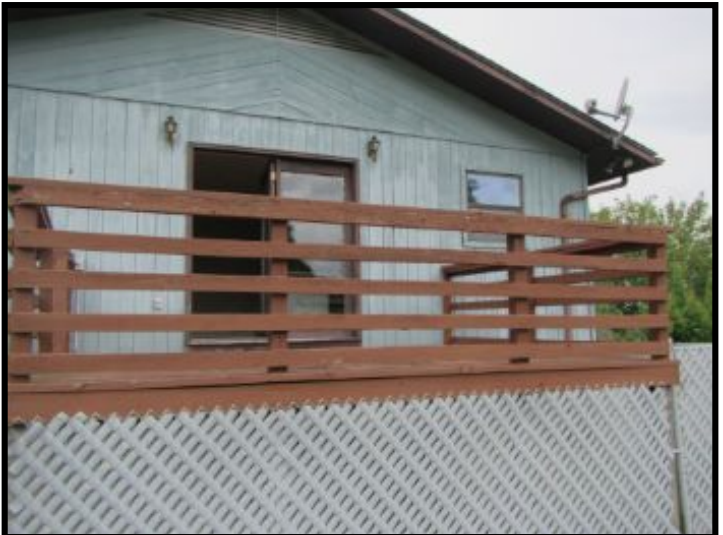
Wood rot on multiple members of the back deck. Fasteners were backing out at several locations.

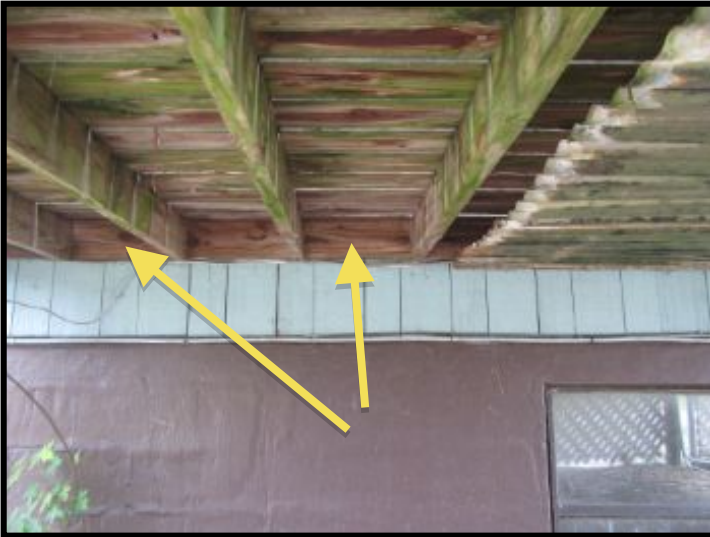
Deck was not lag bolted to the structure.

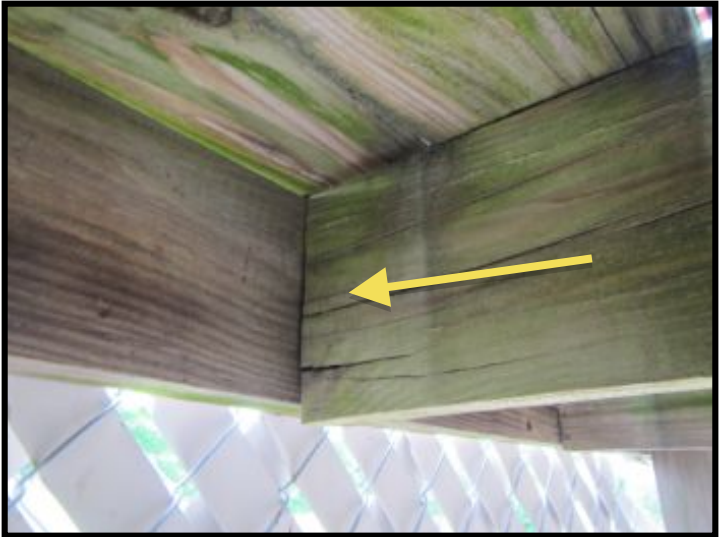
Missing joist hangers at porch/deck.

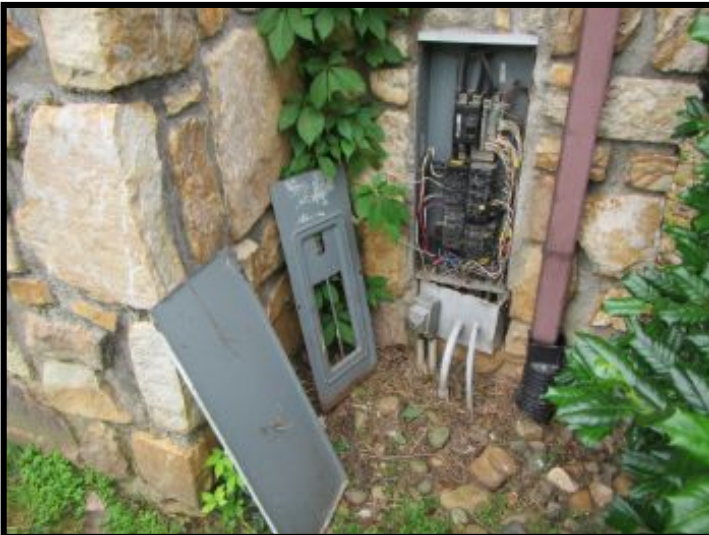
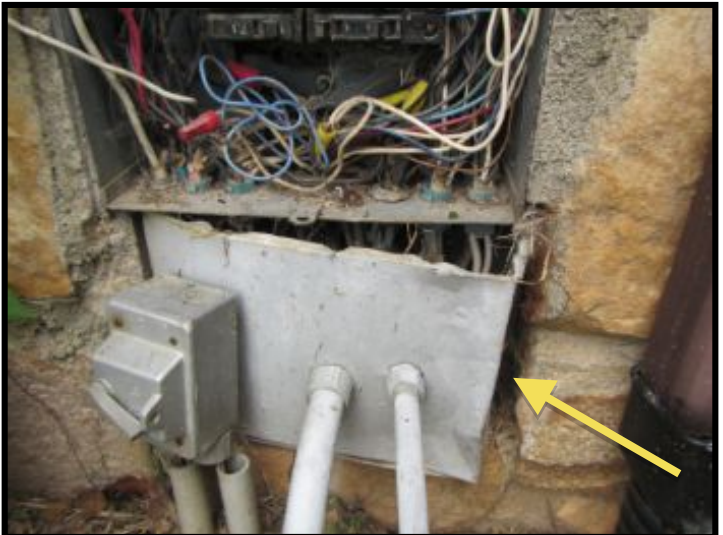
The cover was insecure below the panel that protects the wiring.

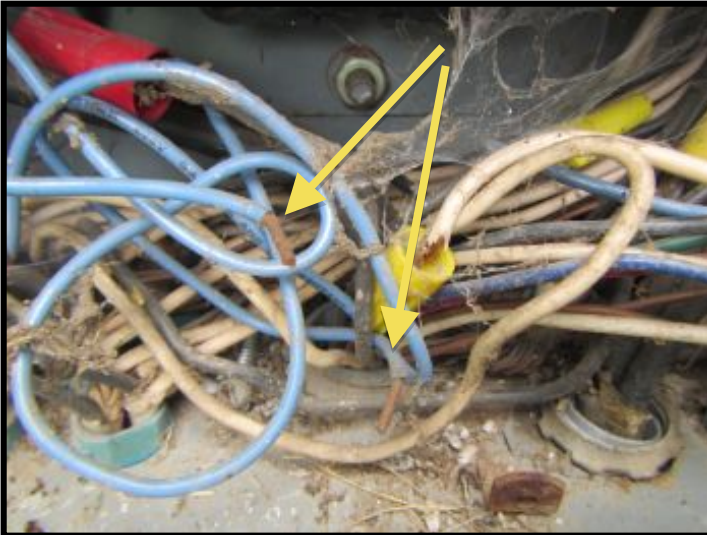
There were uncapped wire ends found inside the panel.

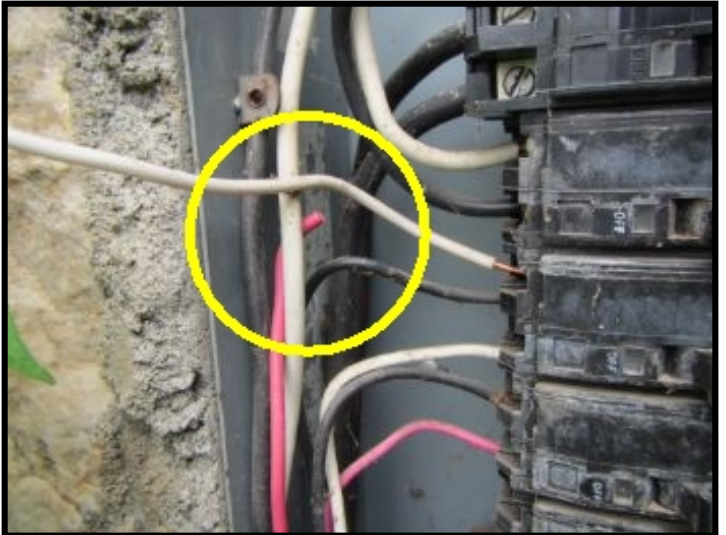
There was an uncapped wire end in the electrical panel (red wire sheathing).

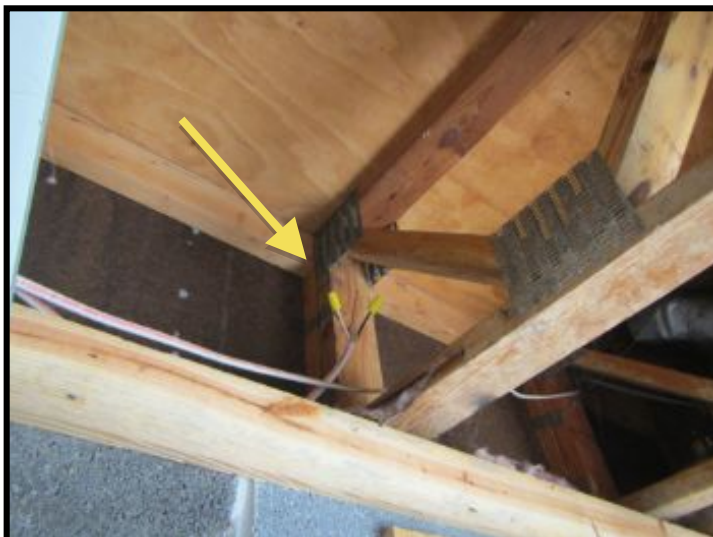
Wire ends not in junction box in garage above back exterior door.

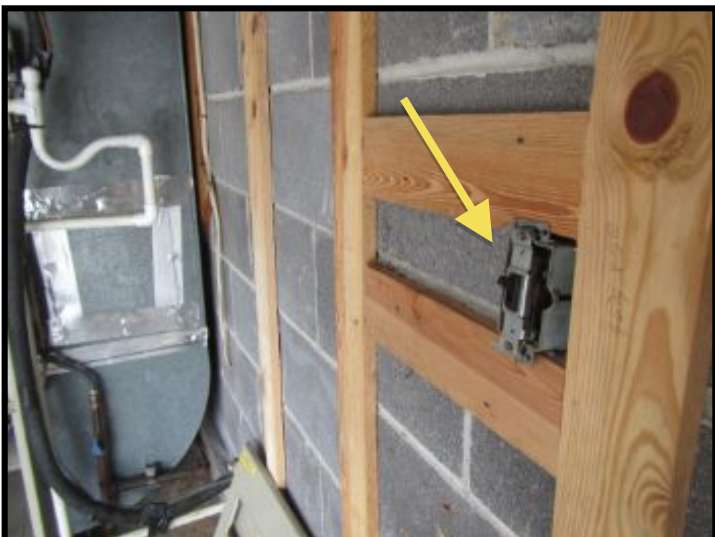
The switch on the back wall in the garage was missing a cover.

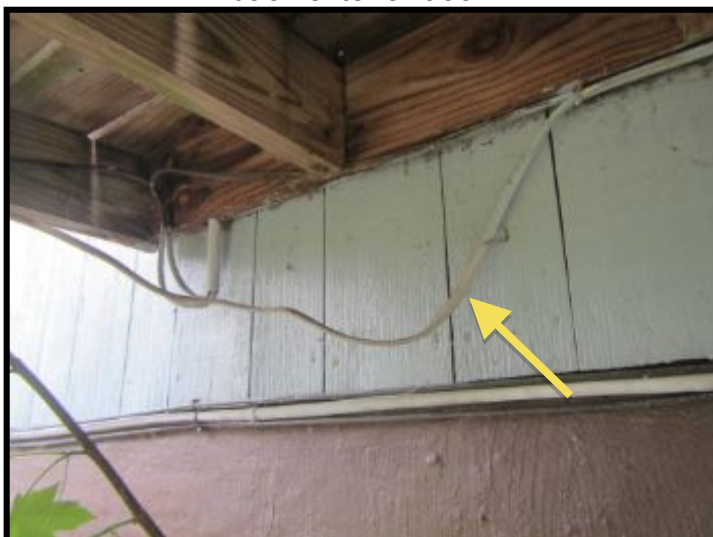
Electrical wiring below the back deck was not protected in electrical conduit.

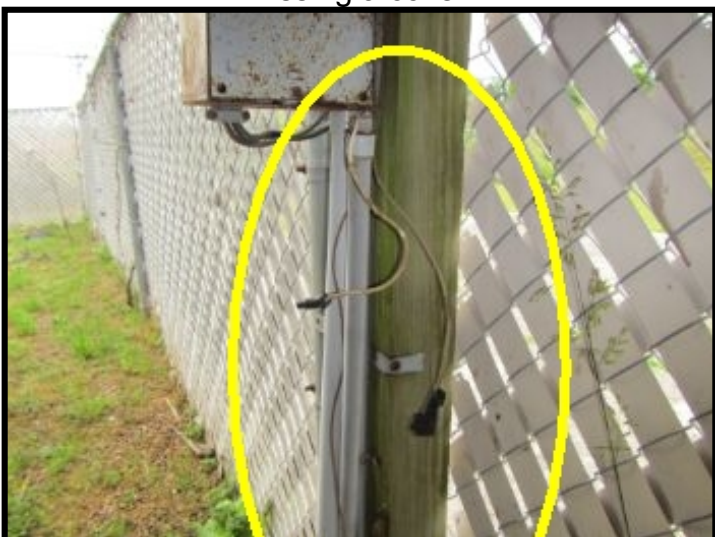
There were improperly terminated wire ends coming from conduit below the back left corner of the back deck.

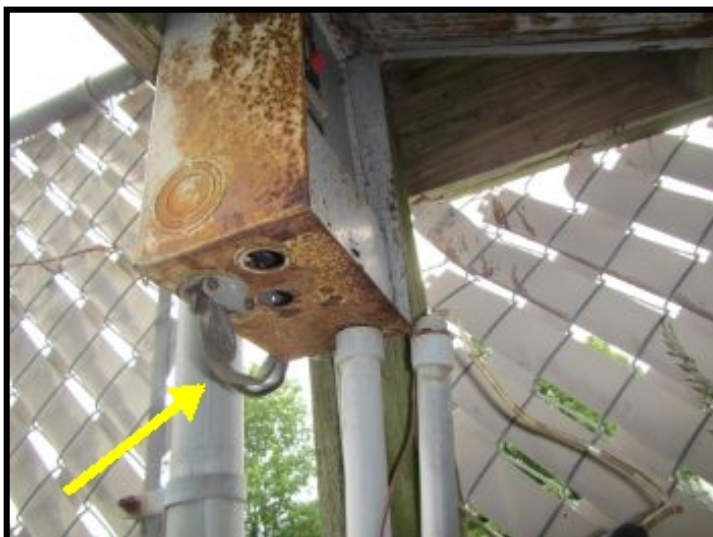
Electrical wiring below the back deck was not protected in electrical conduit.

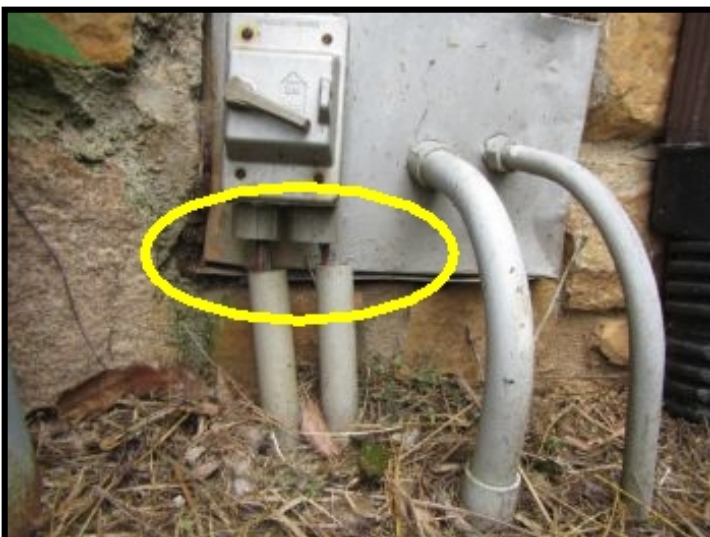
Conduit was insecure at branch wiring below the electrical panel on the exterior of the structure.

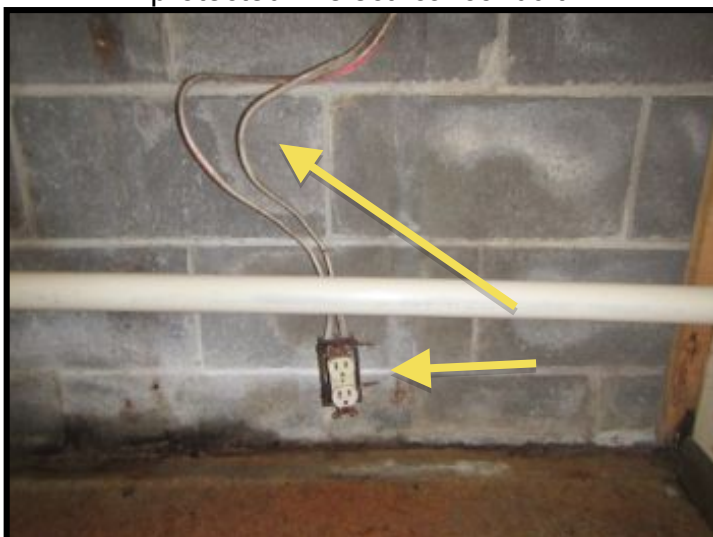
Many outlets in the basement were insecure from the walls, wiring was along the walls and not in conduit.

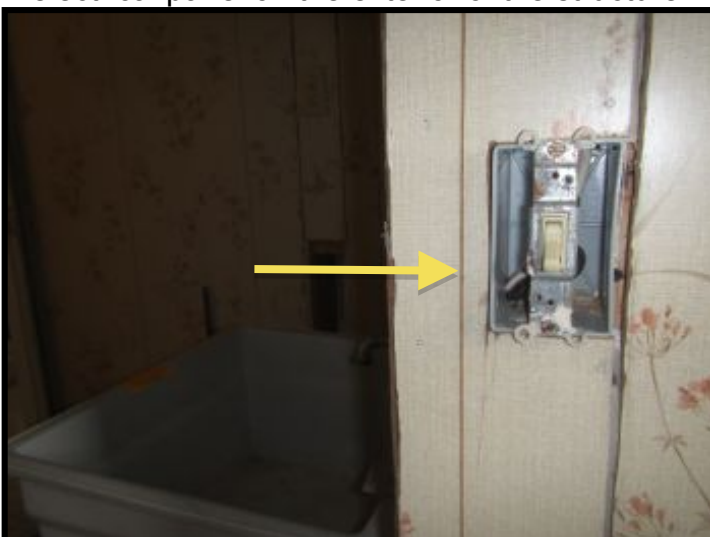
Missing outlet and/or switch coverings in random areas throughout structure
