# Alamo Home Inspections

## Property Inspection Report

Inspection prepared for: [REDACTED]  
Date of Inspection: 6/1/2015

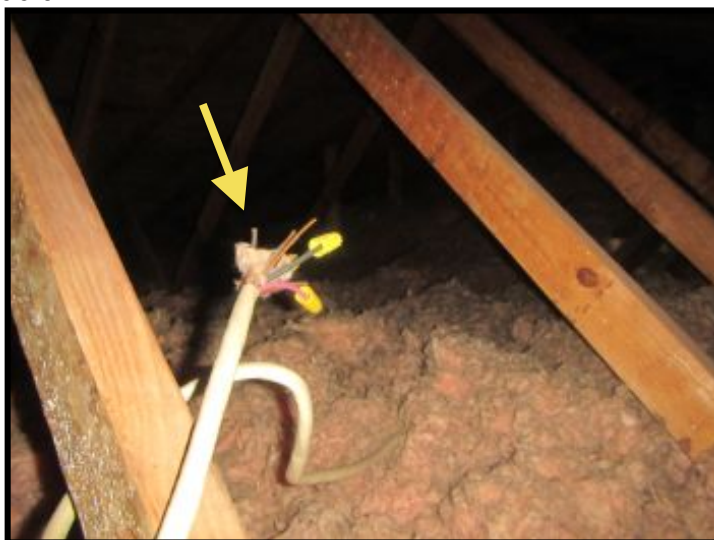
There was an unterminated wire end in the attic at the access.

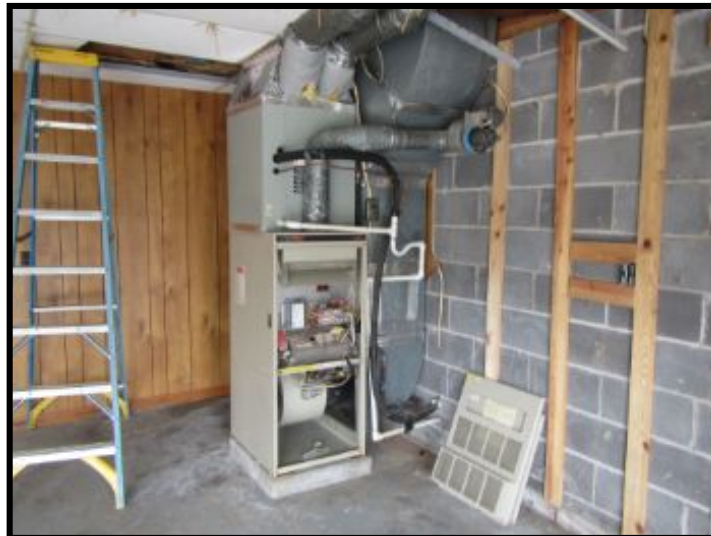
HVAC was being worked on at the time of inspection, inspection of HVAC system was limited for inspector

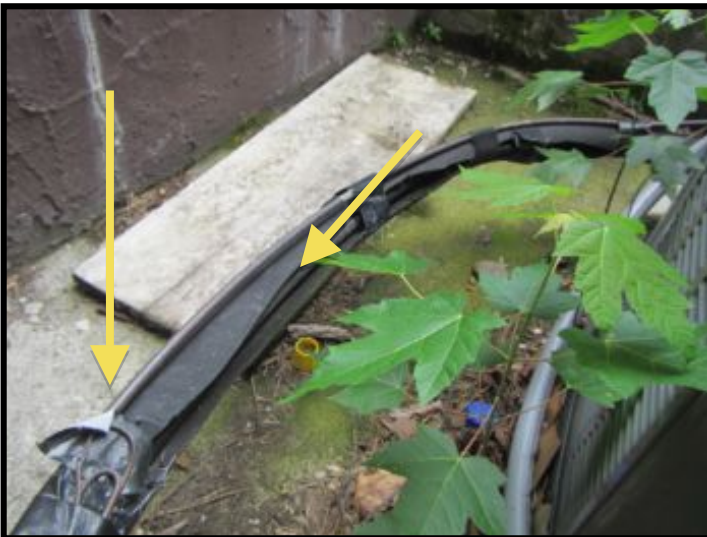
Insulation was damaged/missing at copper tubing connected to the condensing unit

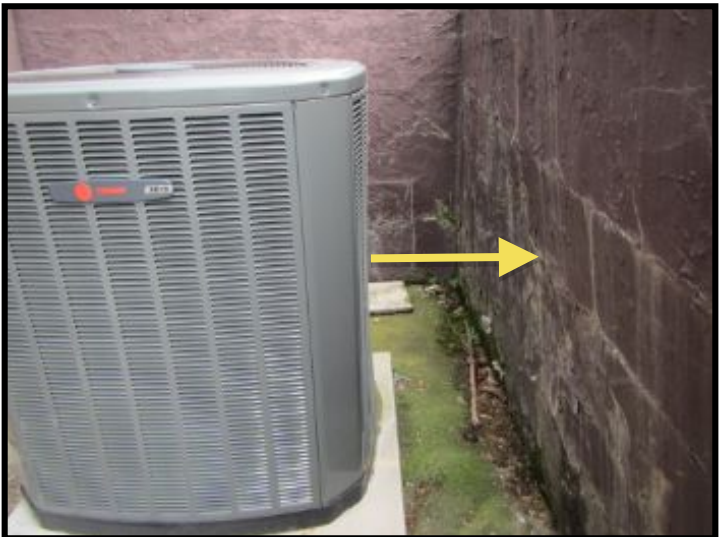
18": The condensing unit was placed within 18" of the structures wall (or other type of restriction: retaining walls, stored items, etc.), this restricts air flow per air conditioner manufacturers recommendations.

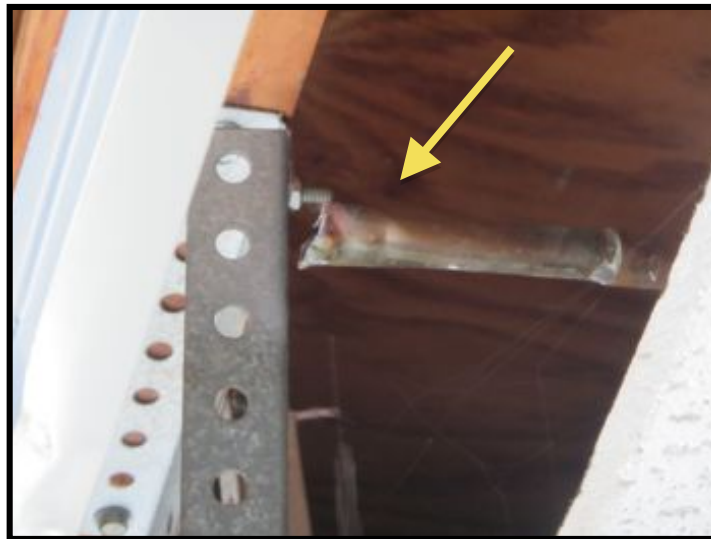
cut copper water pipe in ceiling of garage

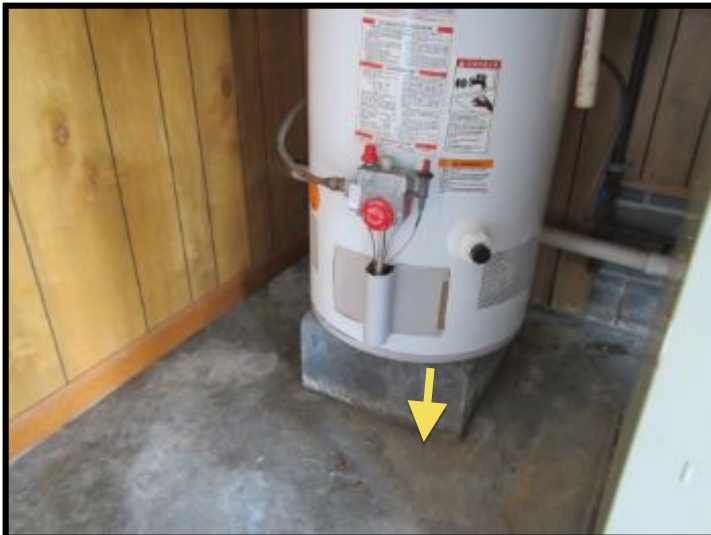
Unit was not elevated 18" as required when unit is located in the garage

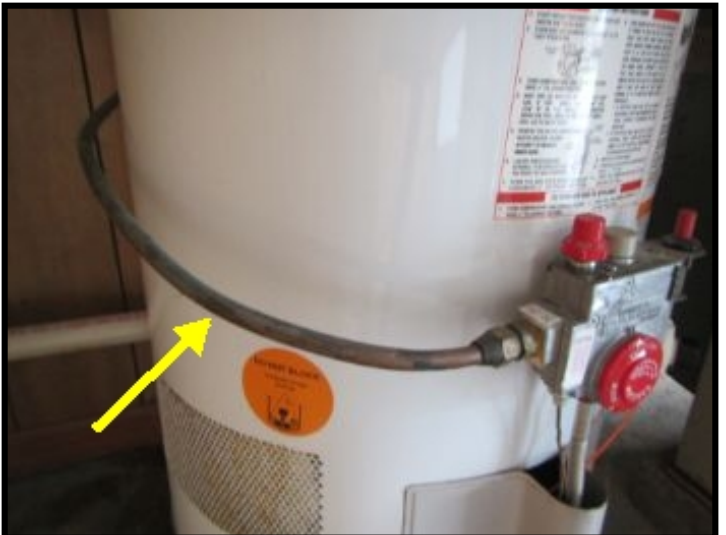
Copper tubing was in use as gas supply line.

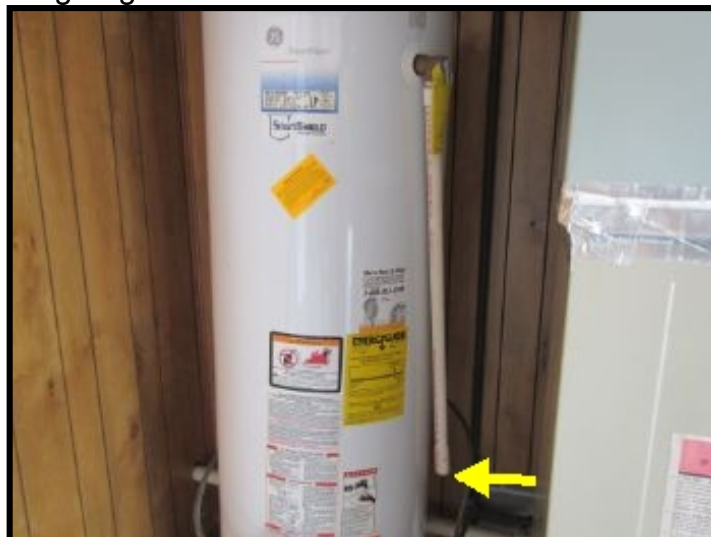
Drain line was too short from the temperature pressure relief valve

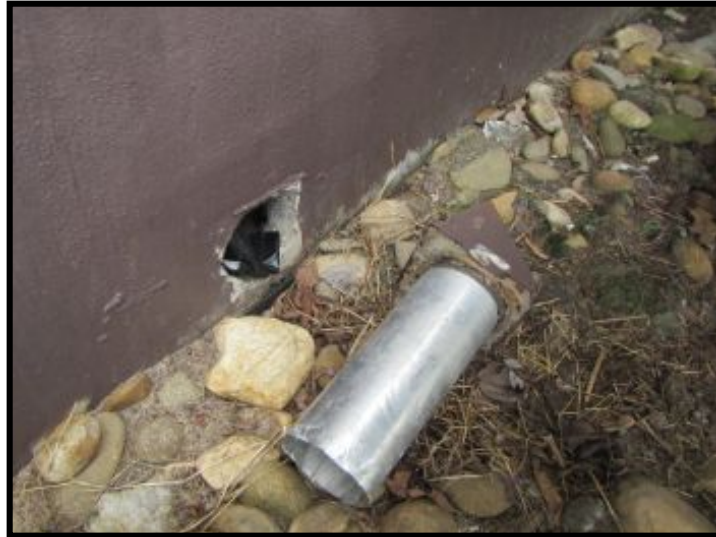
Unit exterior cover was detached/missing.
